## Winter Painting Problems guidance notes

**Almost 80% of problems related to factory finished joinery result from items manufactured and supplied during winter months, typically from December to March**

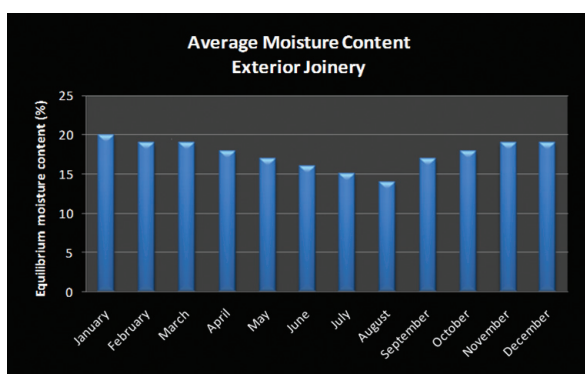
The ambient moisture content of exterior joinery varies significantly through the year and this is generally independent of any treatment or finishes applied to it.

Dimensional change is a function of species and grade, but broadly timber dimensions vary by about 1% for every 3% change in moisture content.

In winter, it is not untypical for joinery to leave the factory at around 10% moisture content, then rapidly condition to 18-20% on site, resulting in dimensional changes of 3-4%, causing joints to open and moisture to penetrate unprotected end grain and rebates.
